On hire-Survey

Container number : JJAU 003057-0

Owner : Halewijn Holding

Date of inspection : 21.02.2025

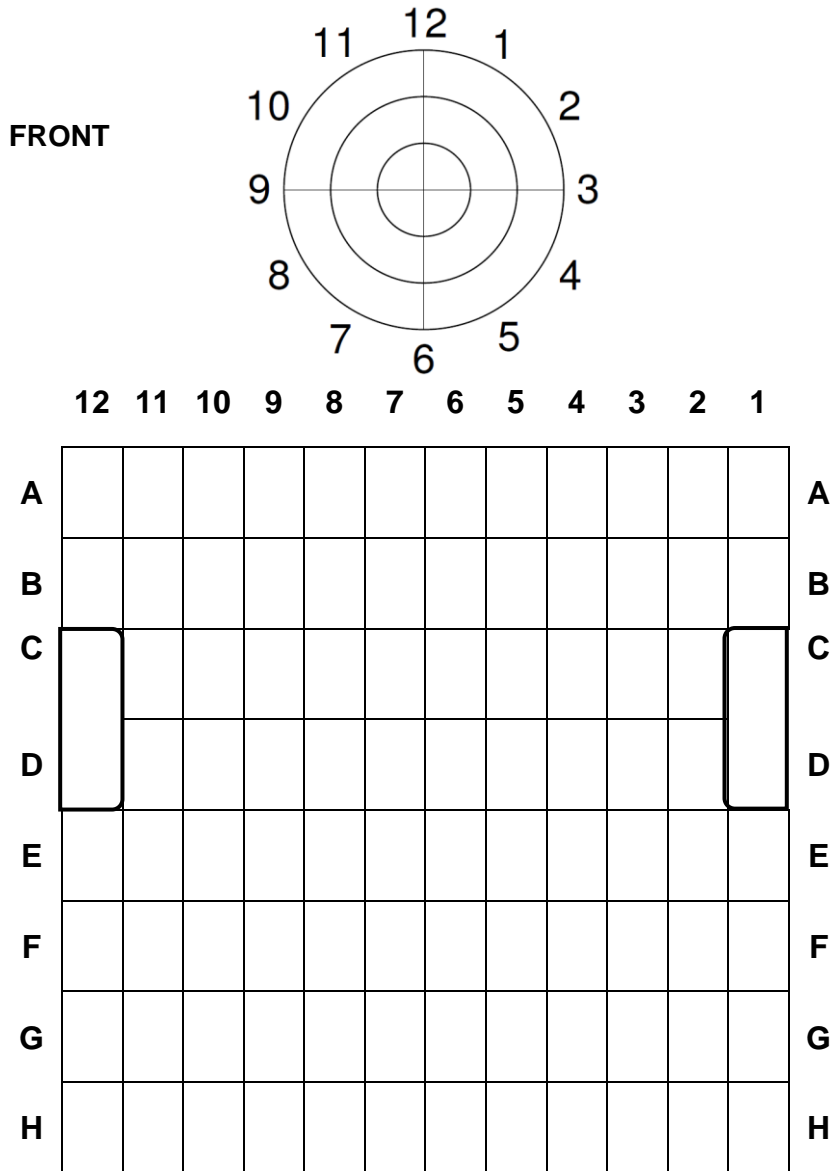
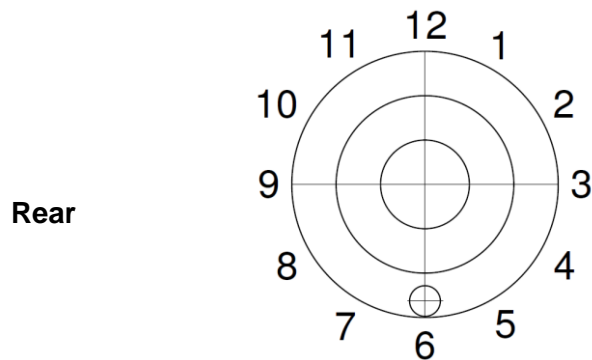
Interior condition:

Brand new tank

Corrosion:	0 %
Polished:	0 %
Discoloured:	0 %

Accepted / Serviceable

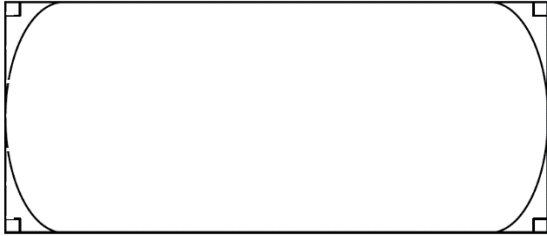
Left hand side

Brand new tank
